ACID CLEANING BRICKWORK

TECHNICAL BULLETIN CTB-15

Rev 3, November 2003

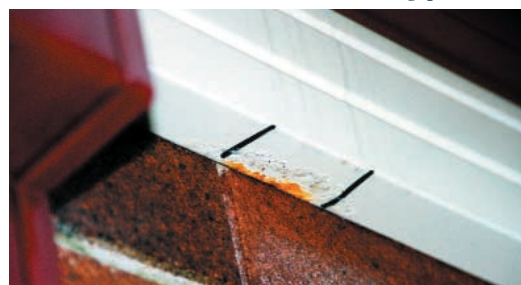
Many of the above items are fabricated from metallic coated steel, such as ZINCALUME® zinc-aluminium alloy coated steel and COLORBOND® prepainted steel. The forming of these items will lead to limited cracking of the coating at the tension bends. Obviously this can result in the penetration of the acid leading to a vigorous corrosive reaction. Normally, the sacrificial ability of the metallic coating is capable of controlling corrosion at these coating defects and negligible corrosion of the material will occur in normal external atmospheric environments.

Figure 1: Example of corrosion caused by incorrect acid brick cleaning practices.

BlueScope Steel Limited recommend that wherever possible acid cleaning should not be conducted subsequent to erection of metallic coated items. However, when this is not possible it is recommended that the areas be appropriately masked during the acid cleaning operation. Where the possibility of inundating the metallic item appears to be present, the item should be thoroughly wetted prior to the application of the acid to the adjacent brickwork. Immediately after acid application, the item should be thoroughly washed with water a number of times, working from the top of the brickwork to allow complete removal of the spent acid products.
