INERT CATCHMENT

TECHNICAL BULLETIN CTB-25

Rev 0, June 2008

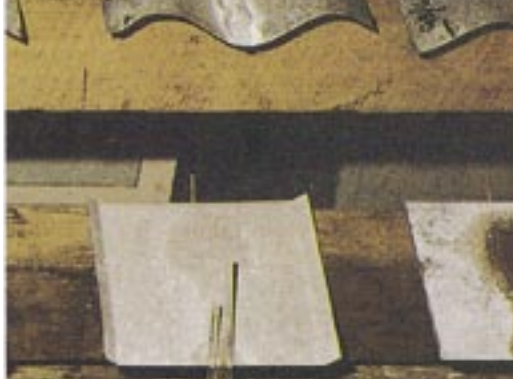
The photographs presented in Tests 1-4 were taken after two years' testing and show that corrosion occurred on a zinc-coated sample below four different roofing material types, including a zinc-coated roof. However, there was negligible corrosion when water flowed from the same four roof types, including the zinc-coated roof, on to ZINCALUME® steel. The test on the ZINCALUME® steel sample was abandoned when no rusting was evident even after it had been exposed without failure for more than 17 times the period it took for rust to form on the zinc-coated sample.

Test 4: Zinc-coated steel to ZINCALUME® steel gutter (*left*); Zinc-coated steel to zinc-coated steel gutter (*right*).

For example, investigation carried out by BlueScope Steel Research has shown that ZINCALUME® steel and ZINCALUME® based COLORBOND® steel will resist corrosion when used as a gutter and downpipe product in combination with any traditional roofing material. ZINCALUME® steel products will perform far better than zinc-coated material.

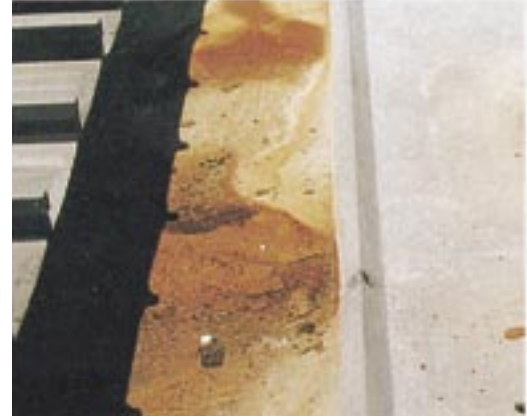
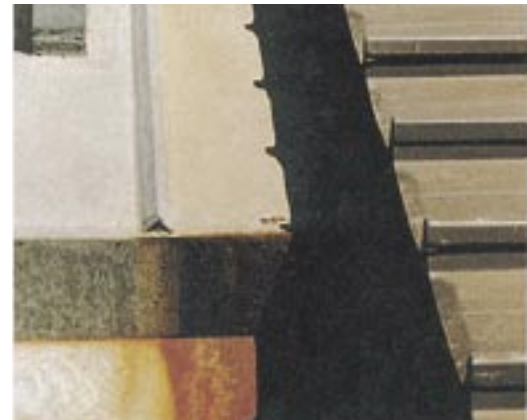
A large shopping complex installed zinc-coated box gutters in combination with roofing of both ZINCALUME® zinc/aluminium alloy-coated steel and COLORBOND® prepainted steel.

Early gutter failure occurred in all the box gutters and downpipes within 18 months because of the “inert catchment” phenomenon, caused by pure rainwater dripping or flowing into the gutters and sumps. Also noted were localised areas of severe corrosion, with complete loss of protective coating. These areas were caused by ponding where water, such as run-off from the air conditioning plants, had been retained for long periods.

Pictures: Severe corrosion caused by ponding and the use of zinc-coated gutters in combination with roofing of both ZINCALUME® zinc/aluminium alloy-coated steel and COLORBOND® prepainted steel.

The specification of COLORBOND® steel, ZINCALUME® steel, COLORBOND® Ultra steel or COLORBOND® Stainless steel gutters and downpipes, installed to avoid ponding by allowing water to flow easily through and away, can prevent the type of corrosion observed in this case study.
